UNION CONGREGATIONAL CHURCH, U.C.C., HANCOCK, MAINE
Pipe Organ Restoration Records – Photo-documentation from 2019,
also supporting the work proposal for summer 2020

from MESSRS. CZELUSNIAK ET DUGAL, INC.
Organbuilders: Restoration & Maintenance
Northampton, Massachusetts

Hook & Hastings Organ Co., Kendal Green, Mass., Opus 2577, 1929, 2 manuals, 7 ranks,
fully Unit Electro-Pneumatic actions, now with Peterson solid-state drive, original setterboard combination action;
built for the Bangor Conservatory; relocated to Bar Harbor, then Schoodic; saved by Stoddard Smith and
Phil Devenish as relocated and rebuilt here in 1988, with additional tonal work by Ed Mickey in 1992

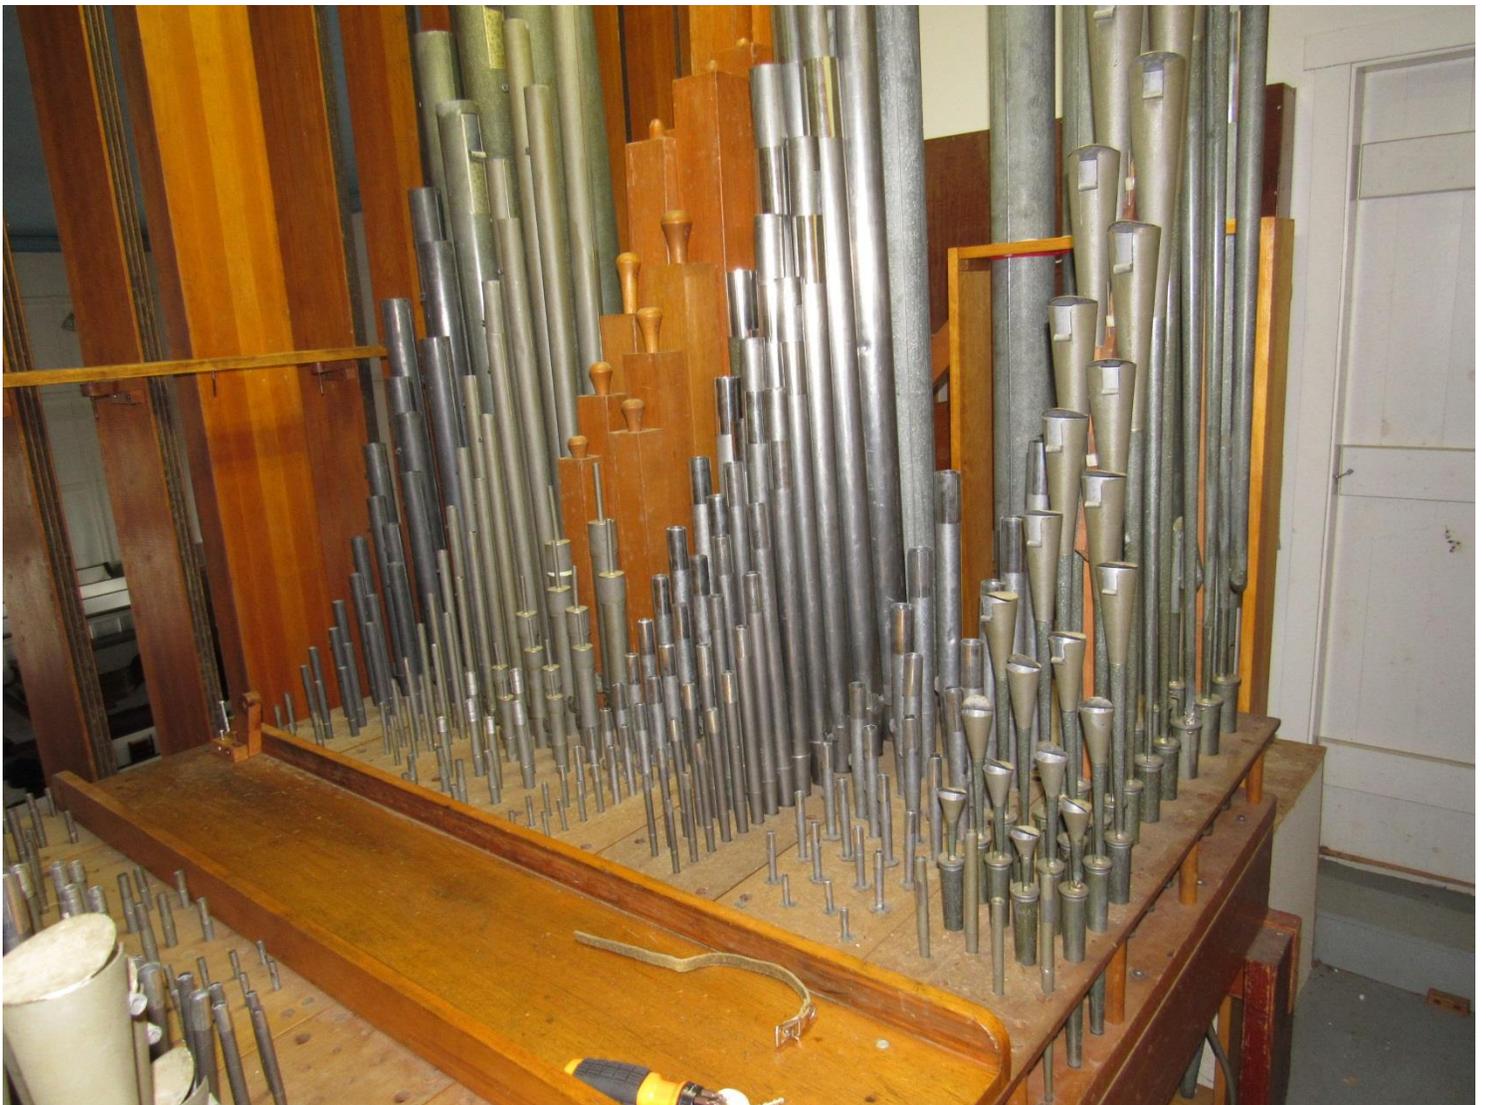
The general setting of the pipe chamber in the rear organ loft, prior to the start of work in the summer of 2019

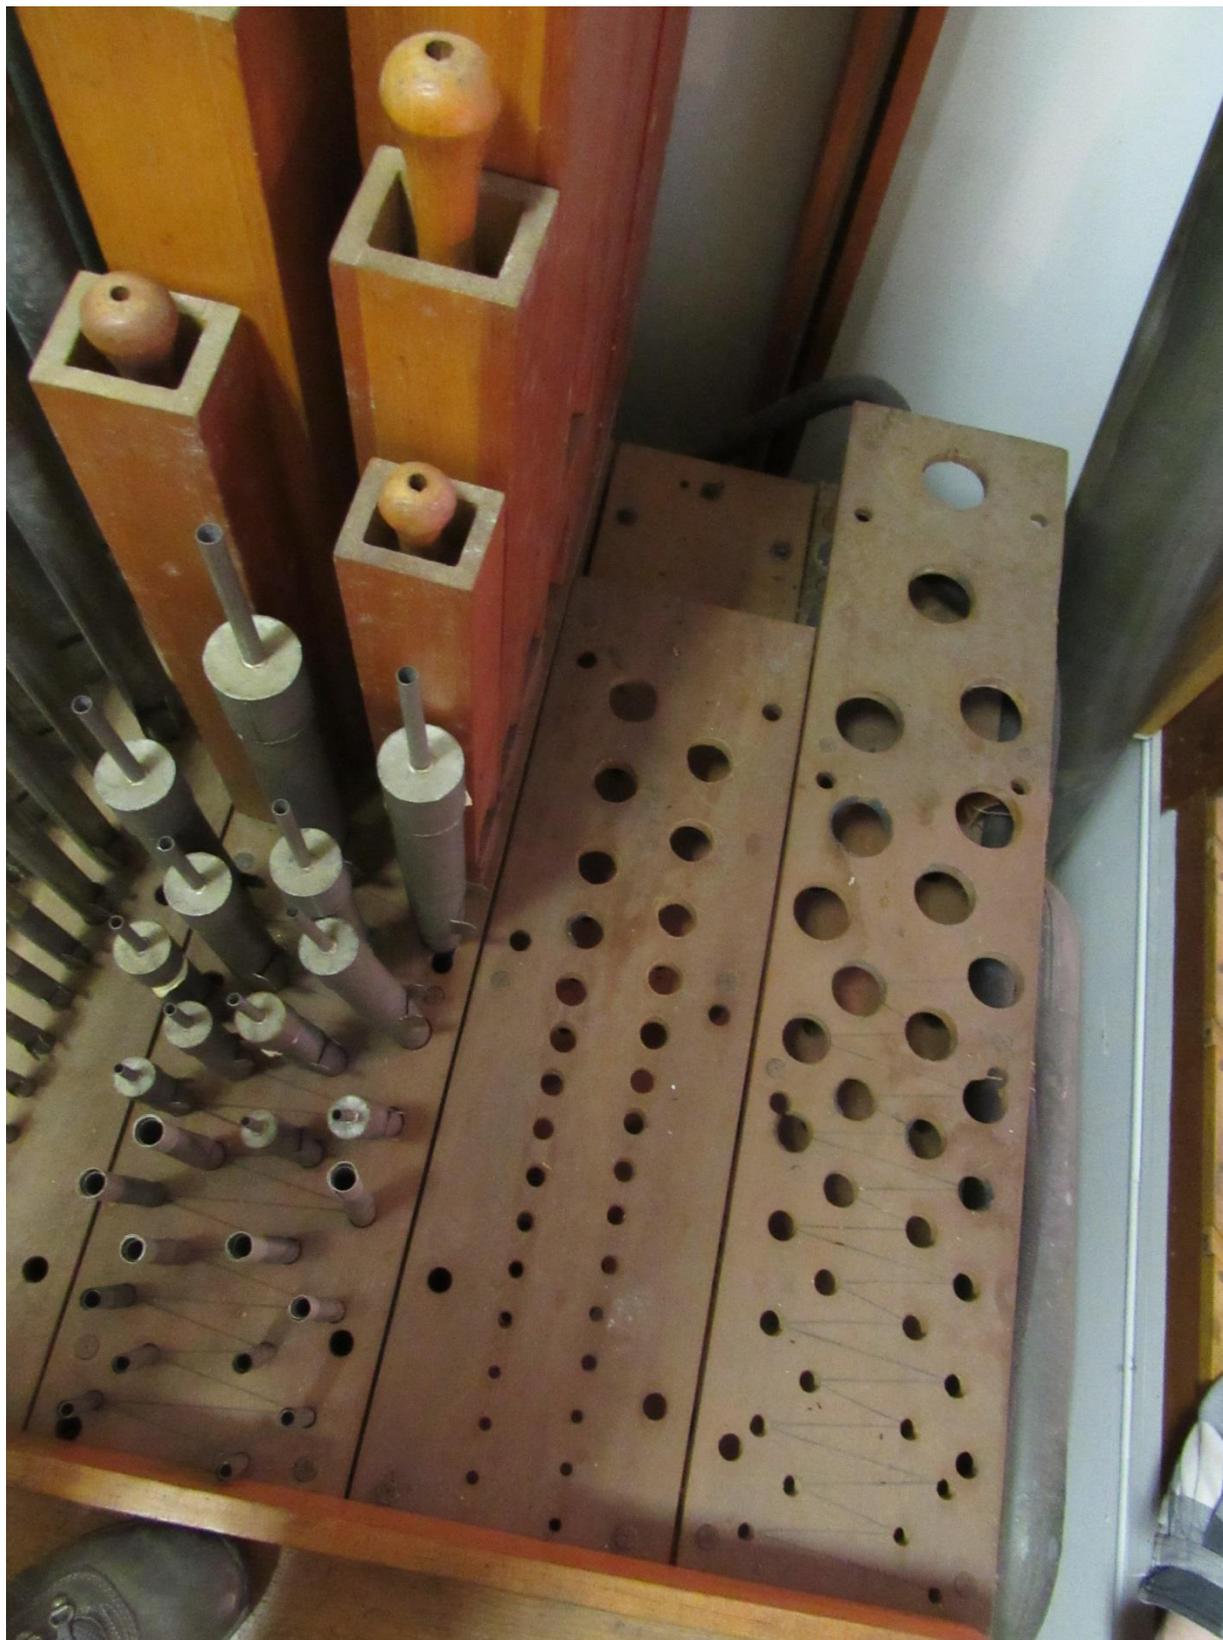
Upon disassembly of the first two unit stops (Open Diapason and Voix Celeste), for thorough restoration at our shop in Northampton, Mass., the condition of the organ in the chamber looked like this. The pipes to the left, which are leaning, were not in that position from having been bumped during work, but rather because they had been lifted from their toe-holes, to mute their speech, as a result of ciphers (constant and uncontrolled wind flow) caused by internal damage from water intrusion. The woodwork simply is aged, if a bit dirty as well.

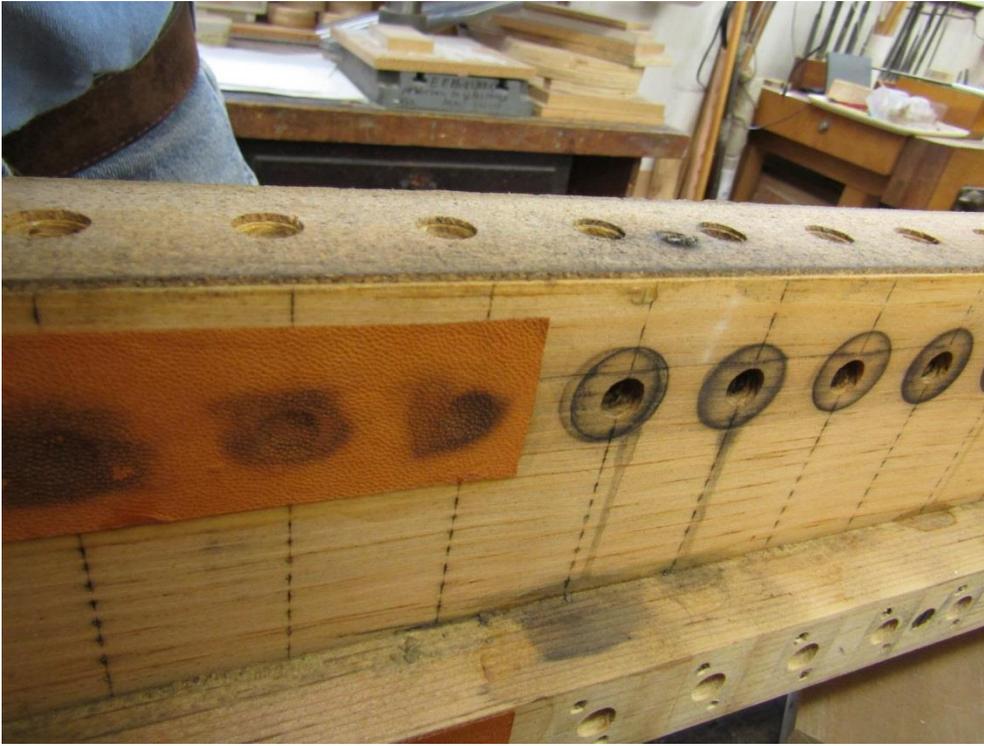
The Ventil Boxes, or windchest bodies... this first image shows interior water damage:

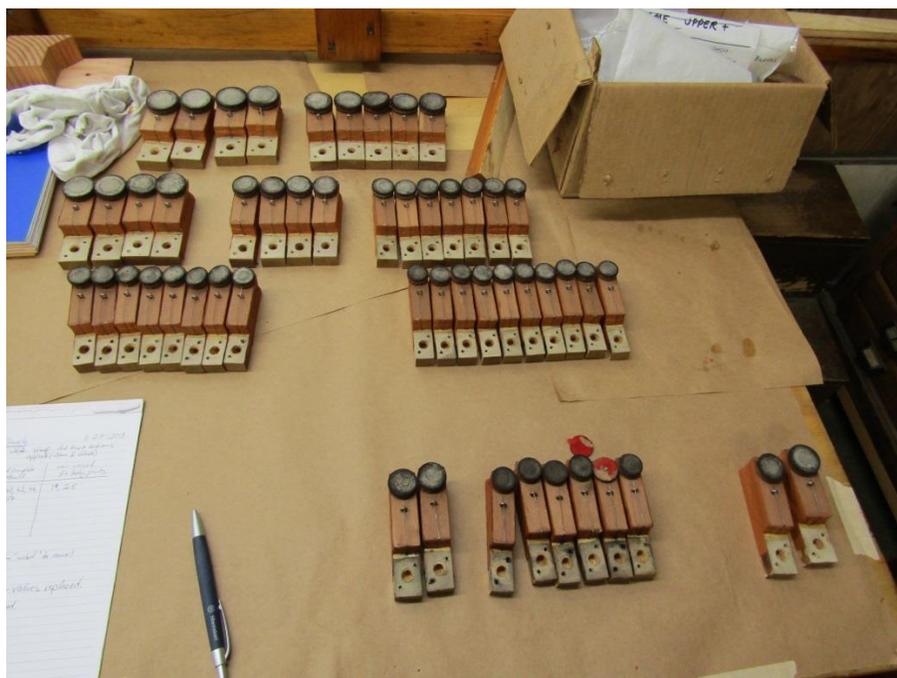
The interior **Note-Action Motors** suffered also from the water intrusion; each of these units was dismantled, tested under pressure, releathered as necessary, and ultimately remounted securely inside the respective Ventil boxes. However, every single action motor received a fresh leather mounting gasket and a new valve face. As initially dismantled, and during testing, these pneumatic actions looked like this:

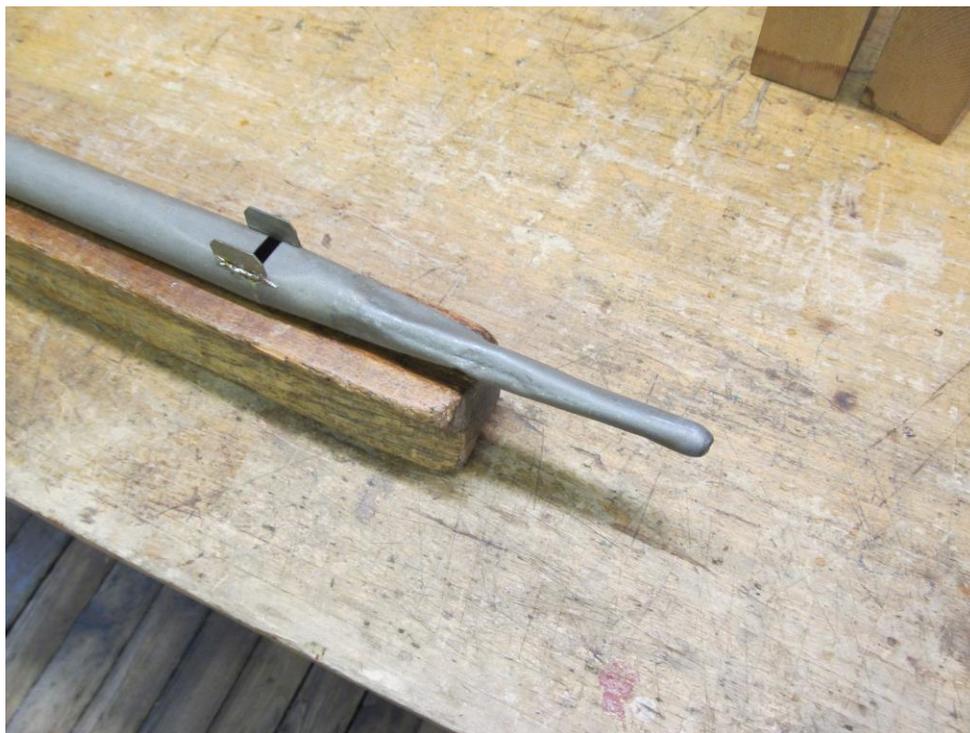
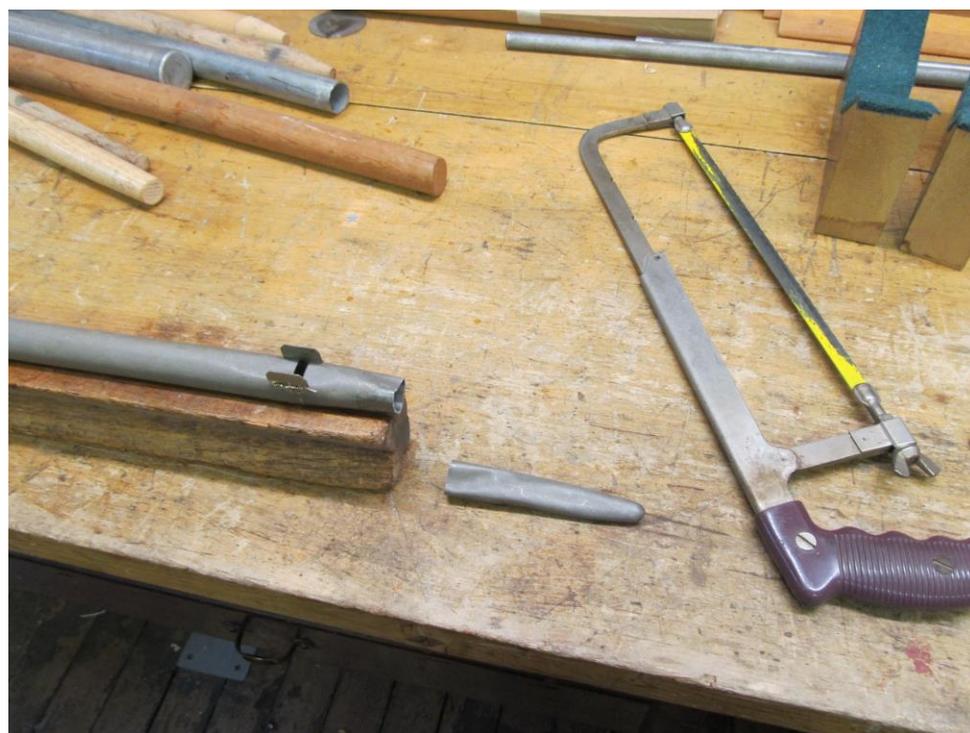
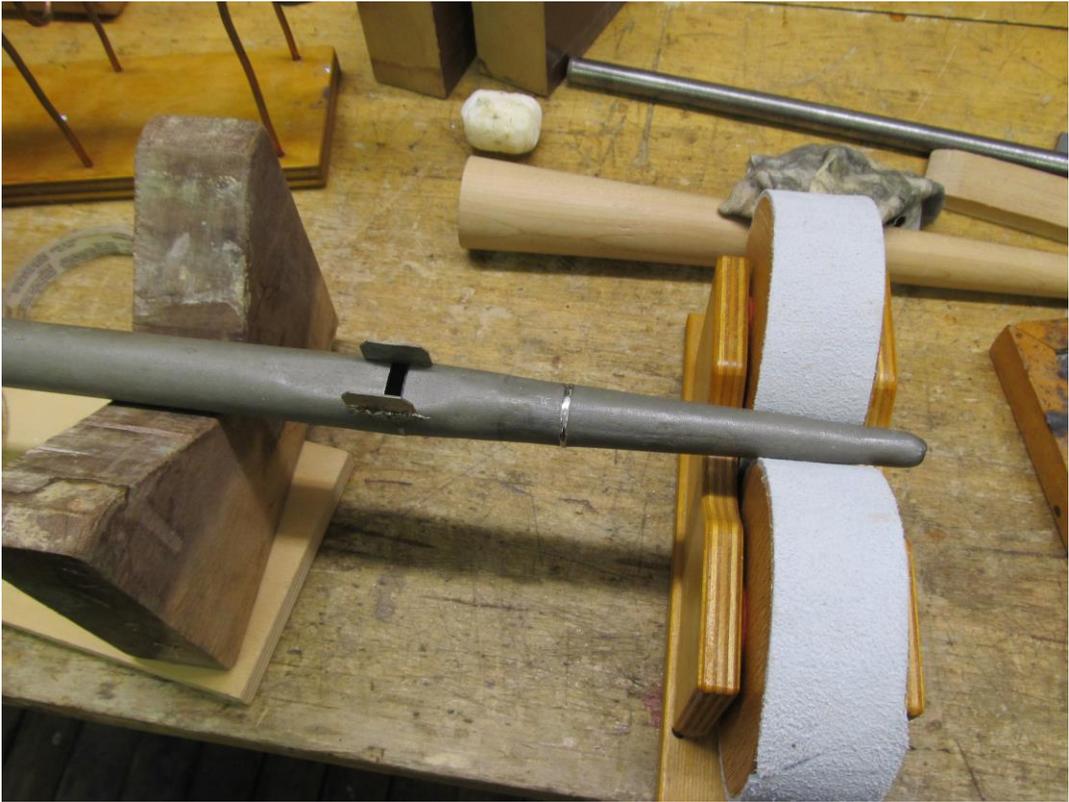
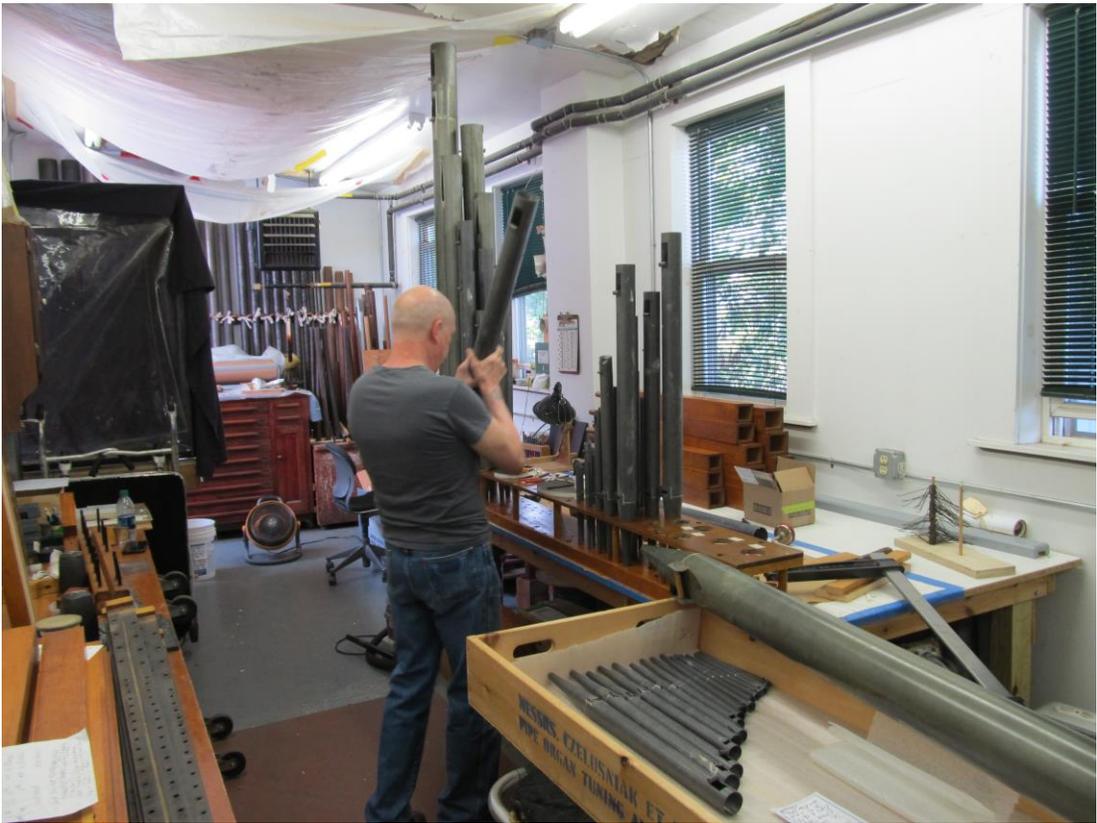
The **Pipework** needed treatment, as well. Some Diapason pipes had been damaged by rodents chewing on the metal at the mouths, and hence would not speak; those pipes were replaced. The Voix Celeste suffered some damage by denting, which was repaired in our own shop. All pipes were refitted to their racks, before leaving the shop, as in the following images.

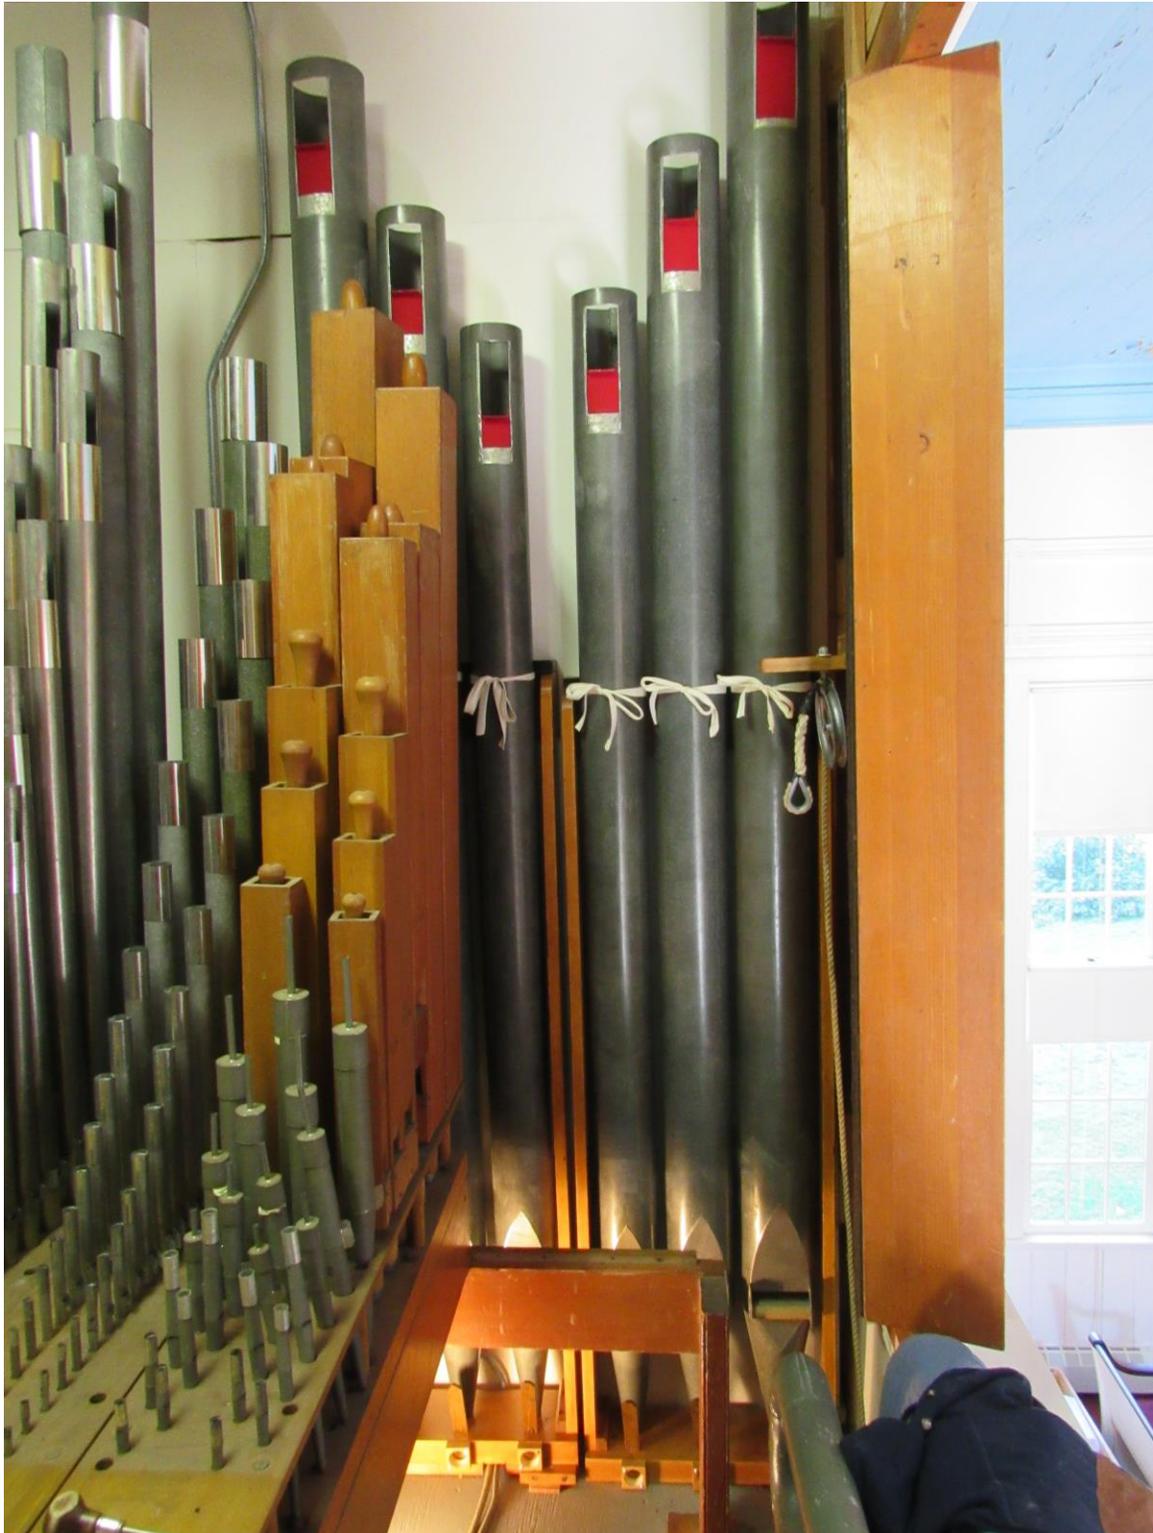
After delivery back to Hancock, Maine, chamber cleaning work preceded reinstallation, reassembly, and reactivation of the pipe organ - of the parts removed temporarily for shop restoration. In this first image, the expression shades have been removed temporarily to permit loading organ components into the chamber. The largest bass pipes of the Open Diapason unit have been reinstalled, offset on the floor of the chamber; note the new, red, internal slide tuners on these large zinc pipes. The structure is ready for placement of the two Ventil boxes restored, while the Stopped Diapason pipes to the left remain askew, muting continual ciphers until restoration is effected there.
