UNION CONGREGATIONAL CHURCH, U.C.C., HANCOCK, MAINE
Pipe Organ Restoration Records – Photo-documentation from 2019,
also supporting the work proposal for summer 2020

from MESSRS. CZELUSNIAK ET DUGAL, INC.
Organbuilders: Restoration & Maintenance
Northampton, Massachusetts

Hook & Hastings Organ Co., Kendal Green, Mass., Opus 2577, 1929, 2 manuals, 7 ranks,
fully Unit Electro-Pneumatic actions, now with Peterson solid-state drive, original setterboard combination action;
built for the Bangor Conservatory; relocated to Bar Harbor, then Schoodic; saved by Stoddard Smith and
Phil Devenish as relocated and rebuilt here in 1988, with additional tonal work by Ed Mickey in 1992

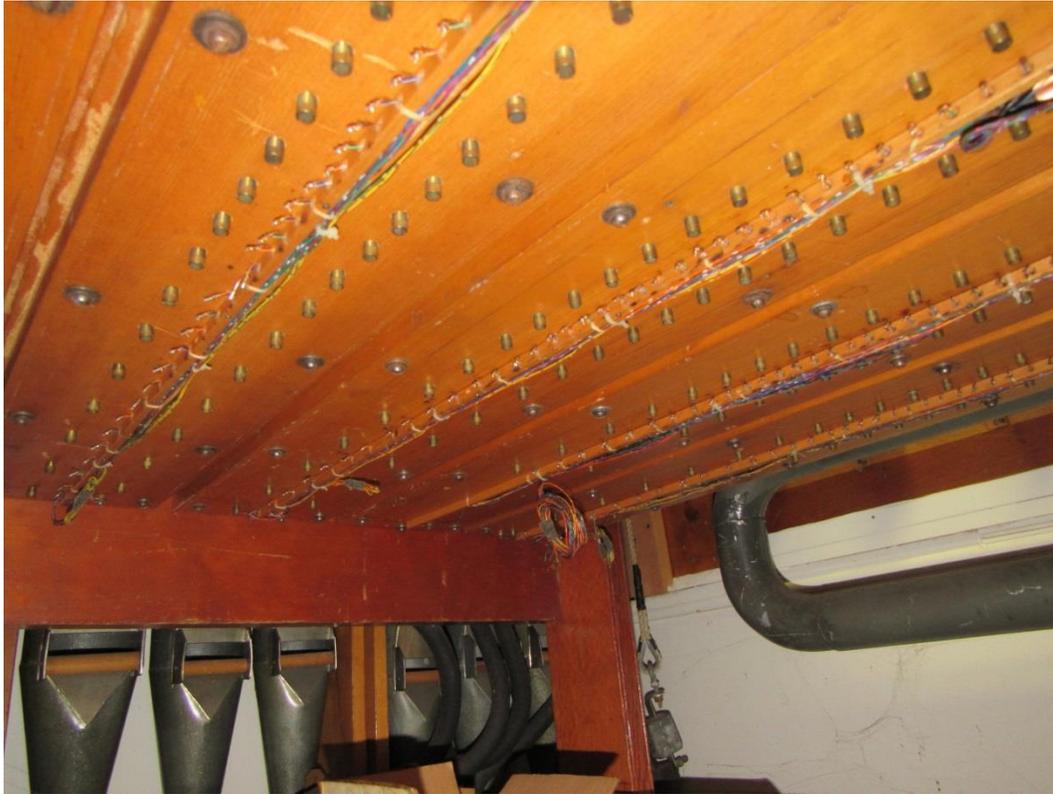
Being of unit-action windchest construction, each pipe in the organ has its own electro-magnet and its own pneumatic valve “motor”, which are housed above and accessed by (respectively) the bottom-boards of the windchests (one Ventil box, as we call them, for each unit rank). In the image below, you will see four of the seven bottom-boards under this main windchest assembly. Each brass nipple is the exhaust port and armature adjustment for the individual electro-magnets inside; the Direct-Current signal wiring for each note is apparent in the color-coded cable. The wind pipe to the right connects to the Tremolo accessory; and, the Open Diapason bass pipes are tubed off to stand on the floor at the rear of the image. This picture illustrates many of the parts that are described for specific treatment in our work records, elaborated herein, and as will be in the forthcoming restoration proposal, also.
